Summary

Four buildings at Aberystwyth football club are proposed for demolition, to allow for construction of new changing facilities and function rooms along with two new open stands and a building for residential use. An assessment of the likelihood of these buildings to support protected species was required by the client. Internally, only one of the buildings has a roof void. This building affords no access to bats. One of the other buildings similarly has no potential access points for bats. The other two buildings are potentially accessible, but are fundamentally unsuited to roosting bats. No evidence of bats was found in any of the structures. The proposed work does not pose any significant risk to protected species.

Survey Details

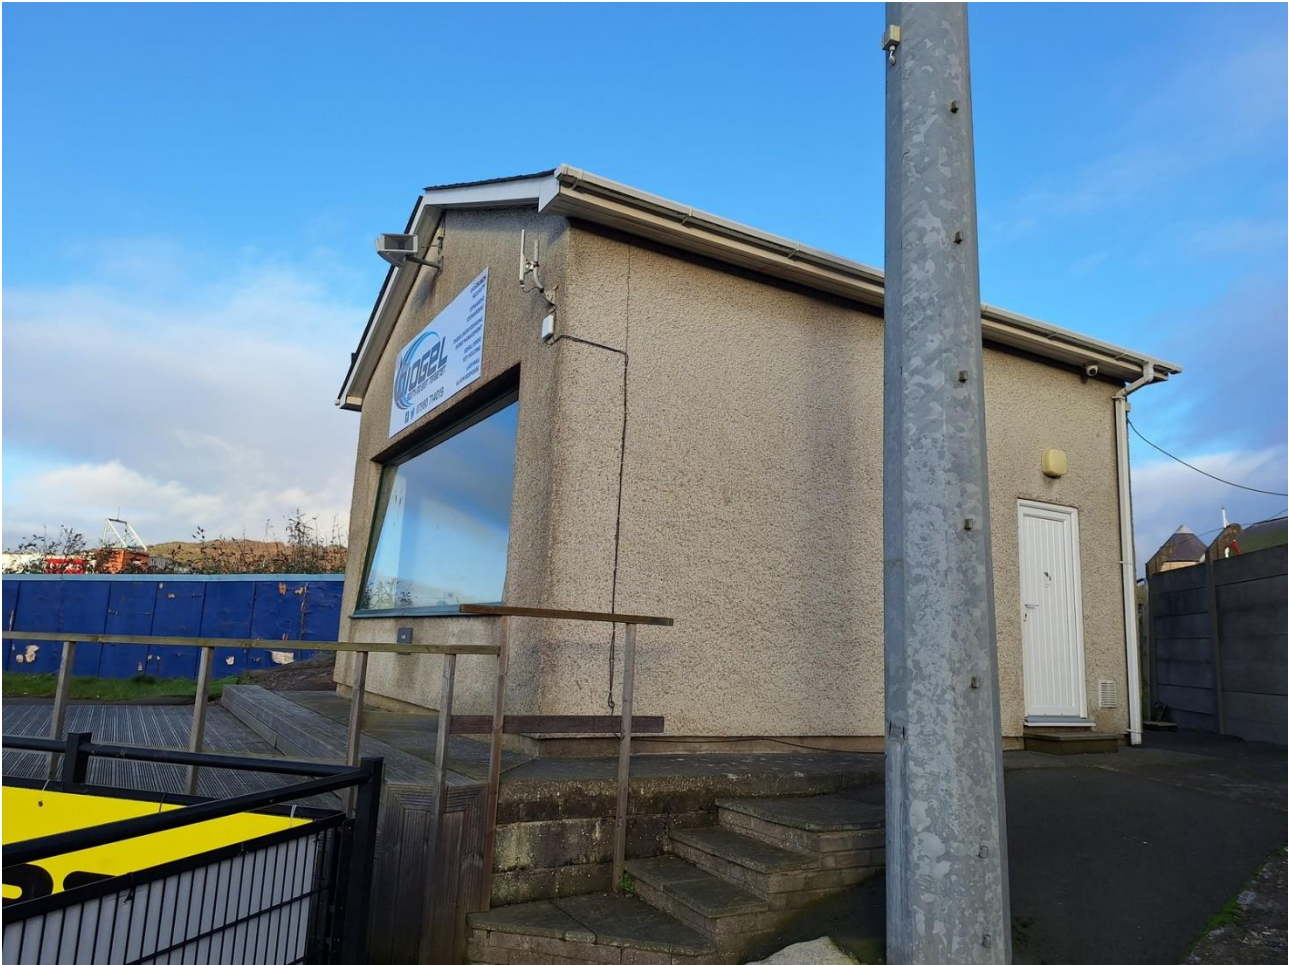
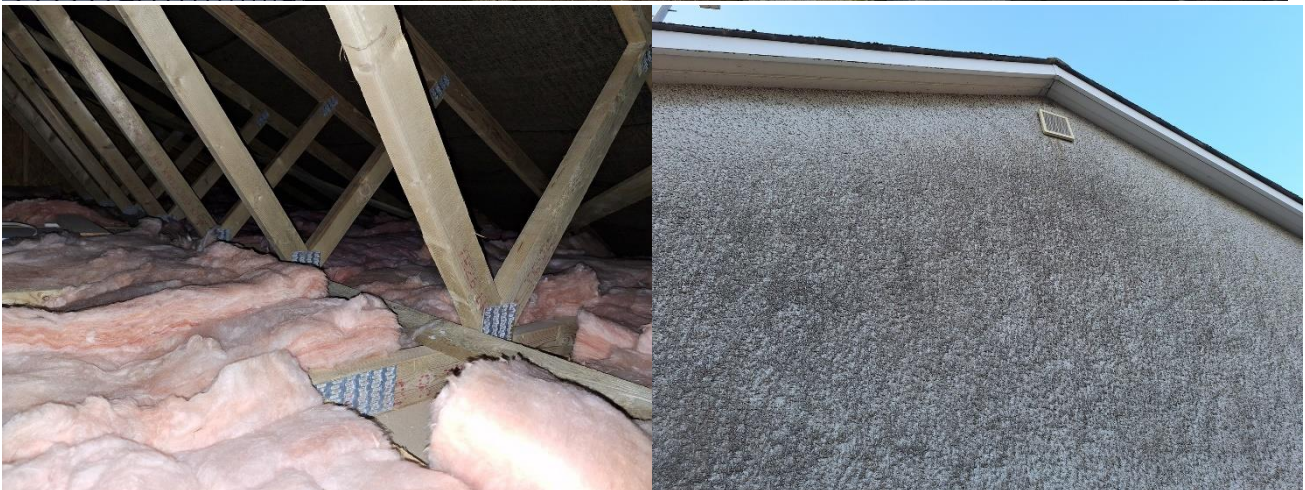
Structure A: Enclosed Viewing Building

This enclosed viewing area is of rendered blockwork construction with an artificial slate roof. uPVC soffits and fascias are tightly-fitted to the wall-tops and afford no squeeze gaps. All slates are intact and closely-fitted; ridge tiles are intact and mortared. Internally, there is a small roof void, with mineral wool insulation between floor joists and an intact membrane below the slates.

The building has no potential access points for bats, and no external features which could be used. The roof-space was accessed and found to be clean and completely sealed; no droppings or other signs of bats were found.

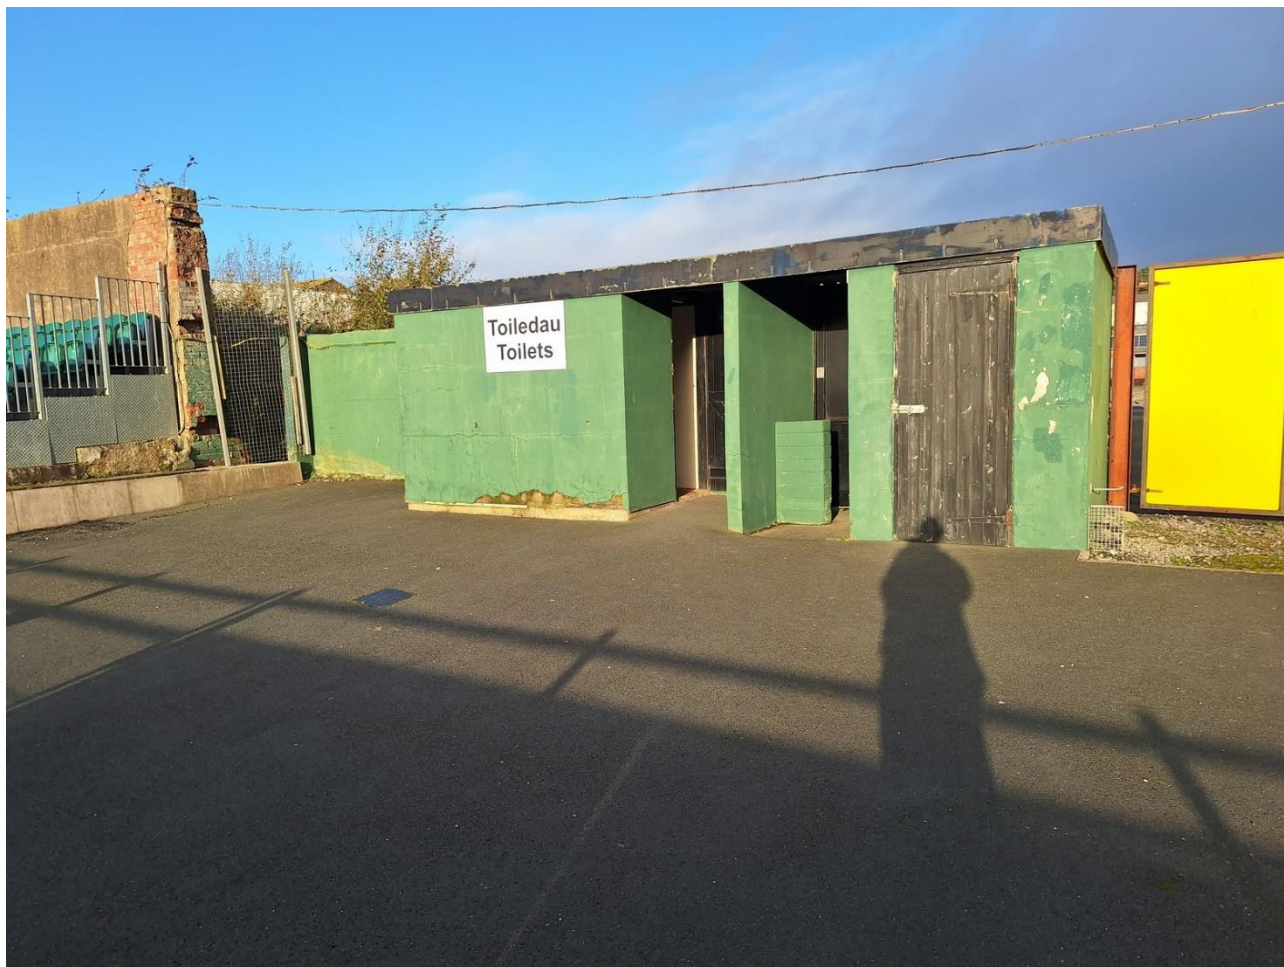
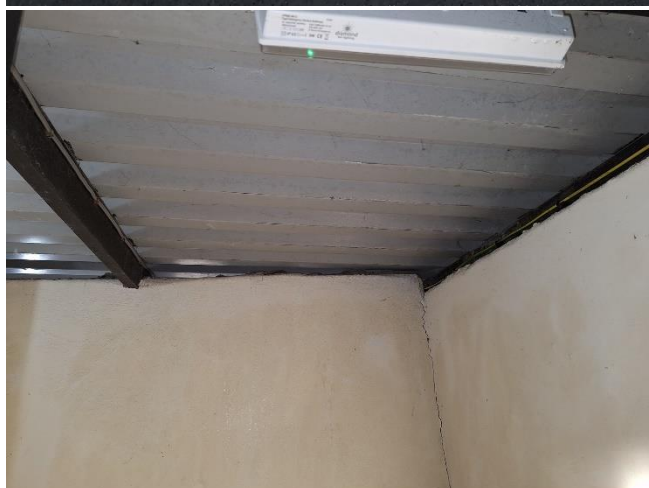
Structure B: Toilet block and turnstile building

This simple building has painted concrete blockwork walls with a shallow mono-pitched metal roof, folded over the wall-tops. There is an open doorway to the toilet section, but no roof-void inside.

No droppings or other evidence of bats was found. There are no internal spaces or external features which could be exploited by roosting bats.

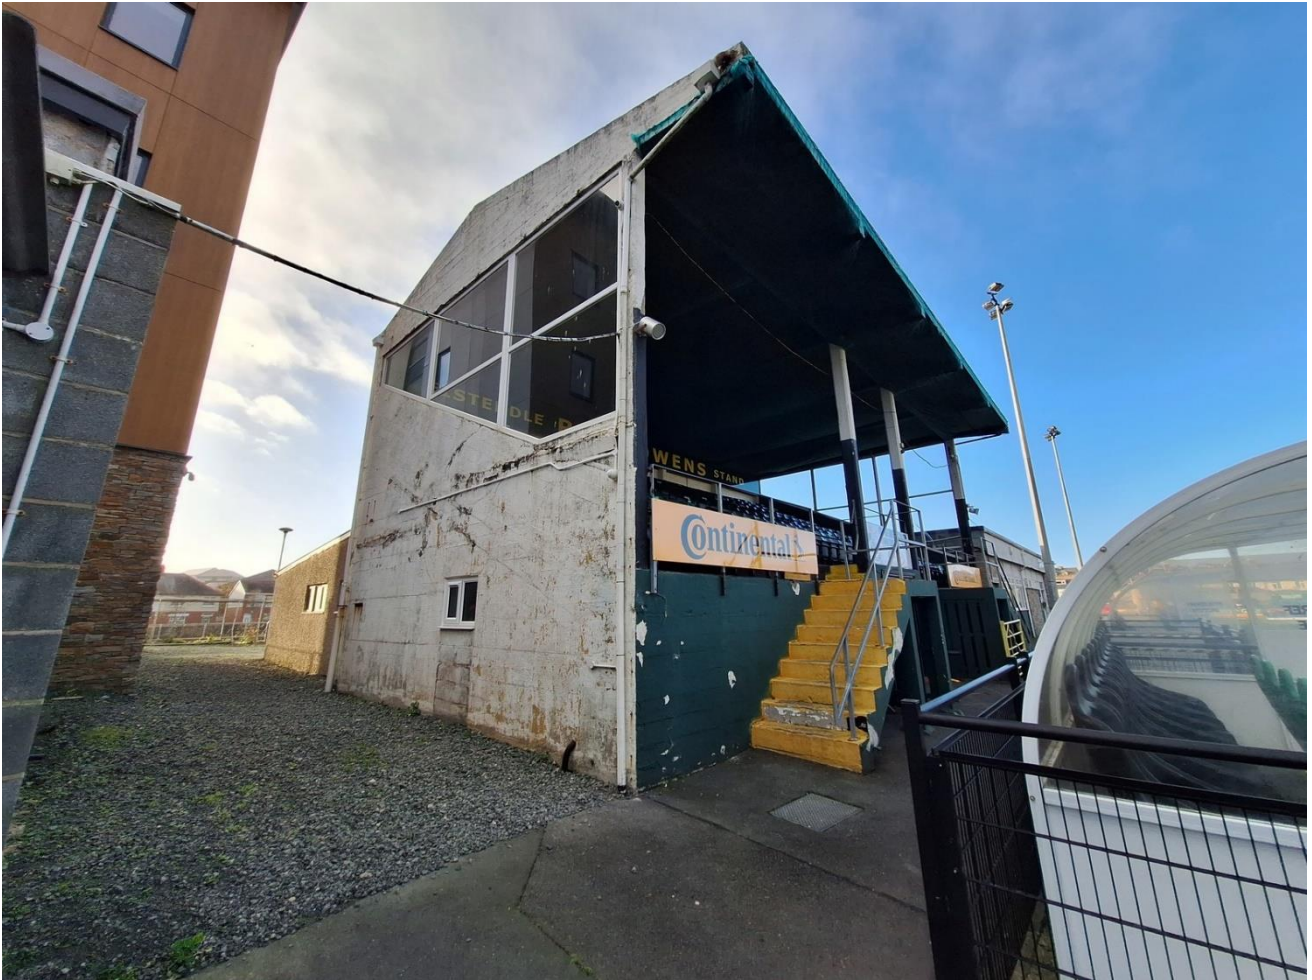
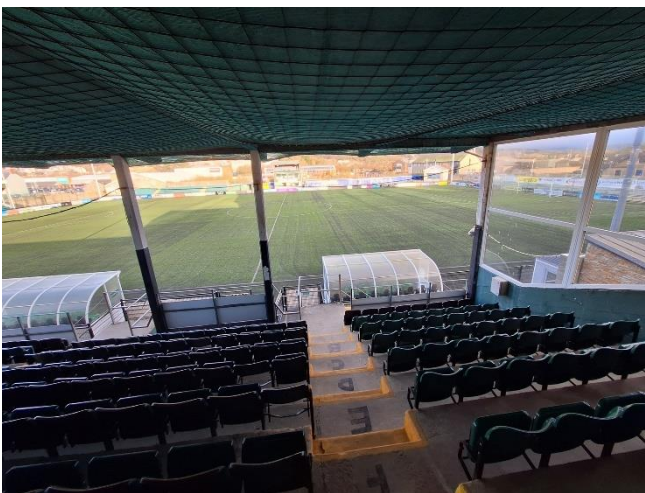
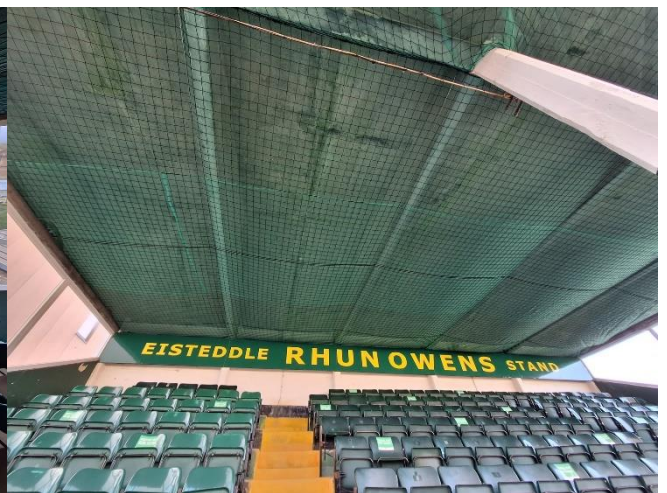
Structure C: Spectator Stand

This open-fronted stand has a metal roof, lined on the inside with netting. There are no features on or inside the stand which could be exploited by roosting bats. There is an area below the stand enclosed by concrete walls; survey access was not possible here, but no potential bat access points were apparent.

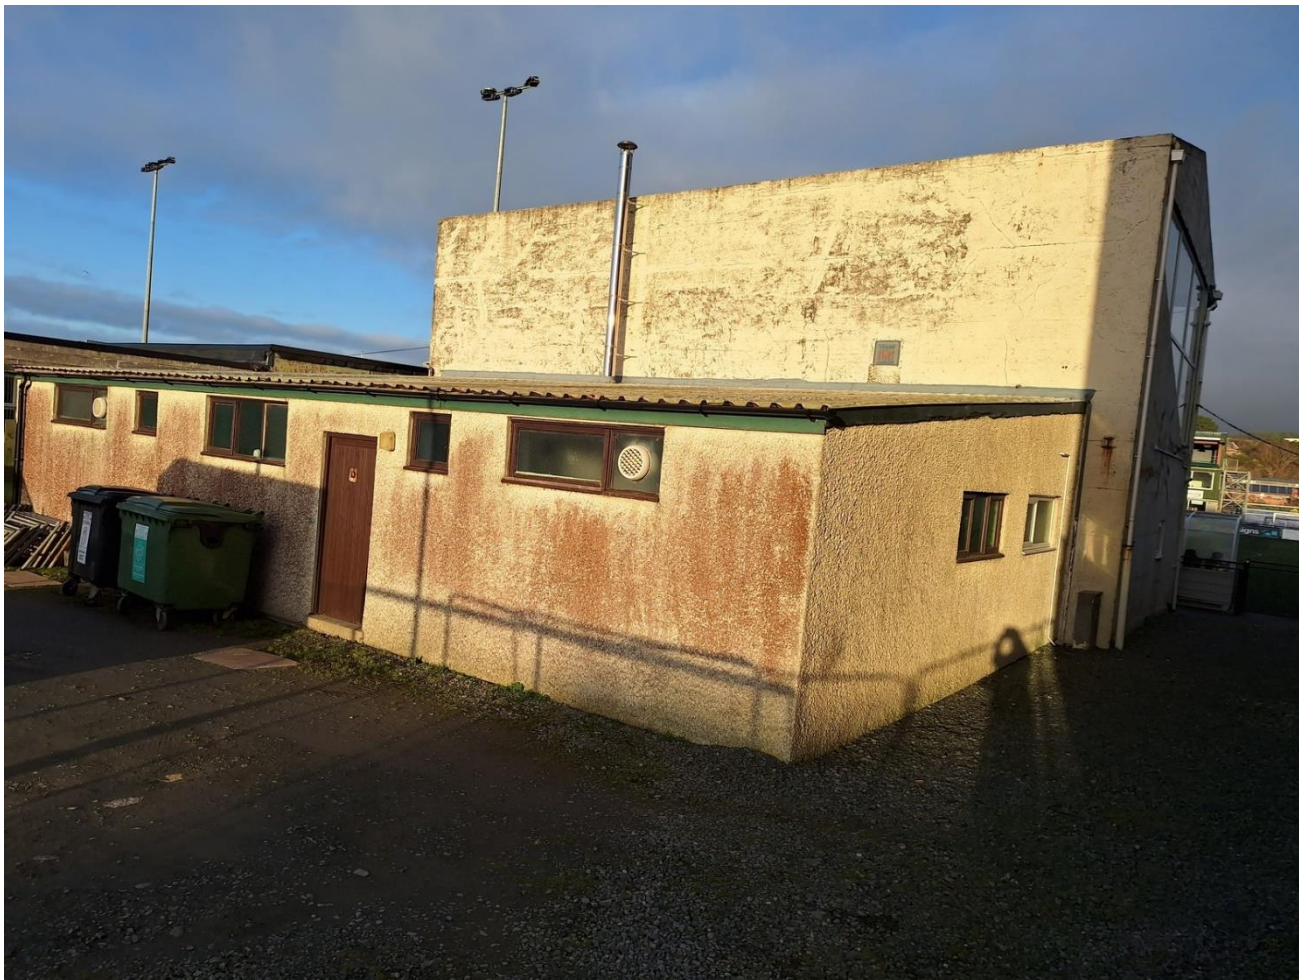
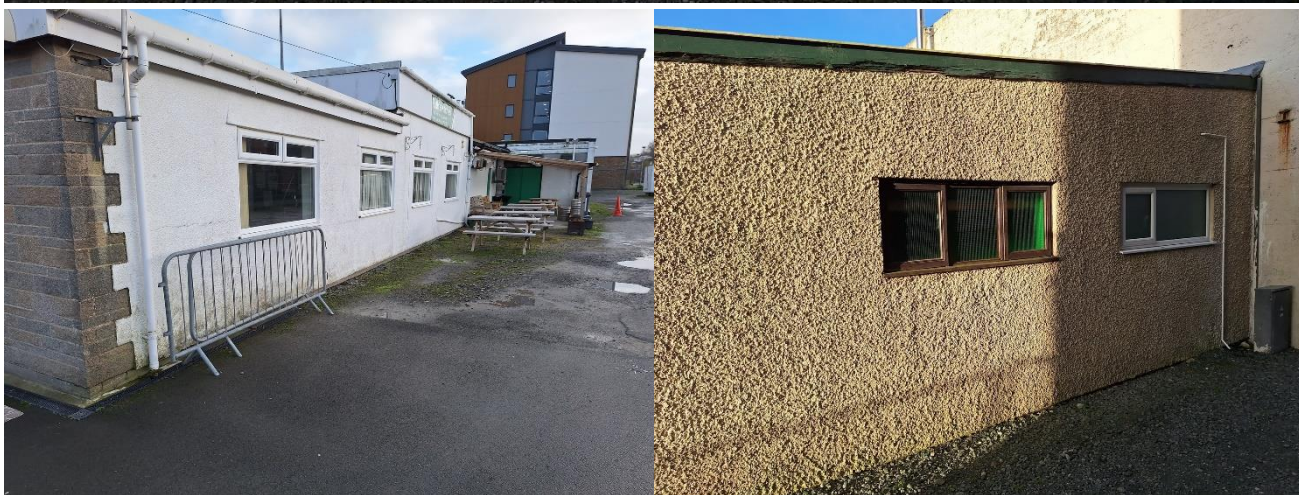
Structure D: Clubhouse / Changing Rooms

Two flat-roofed buildings lie to the rear and side of the spectator stand. These are variously concrete block or brick-walled; the clubhouse walls are well-glazed. The clubhouse roof is reportedly lined with solid insulation, whilst the changing room block has a corrugated metal roof. Neither building has a roof void, or any internal or external features which could be exploited by roosting bats.

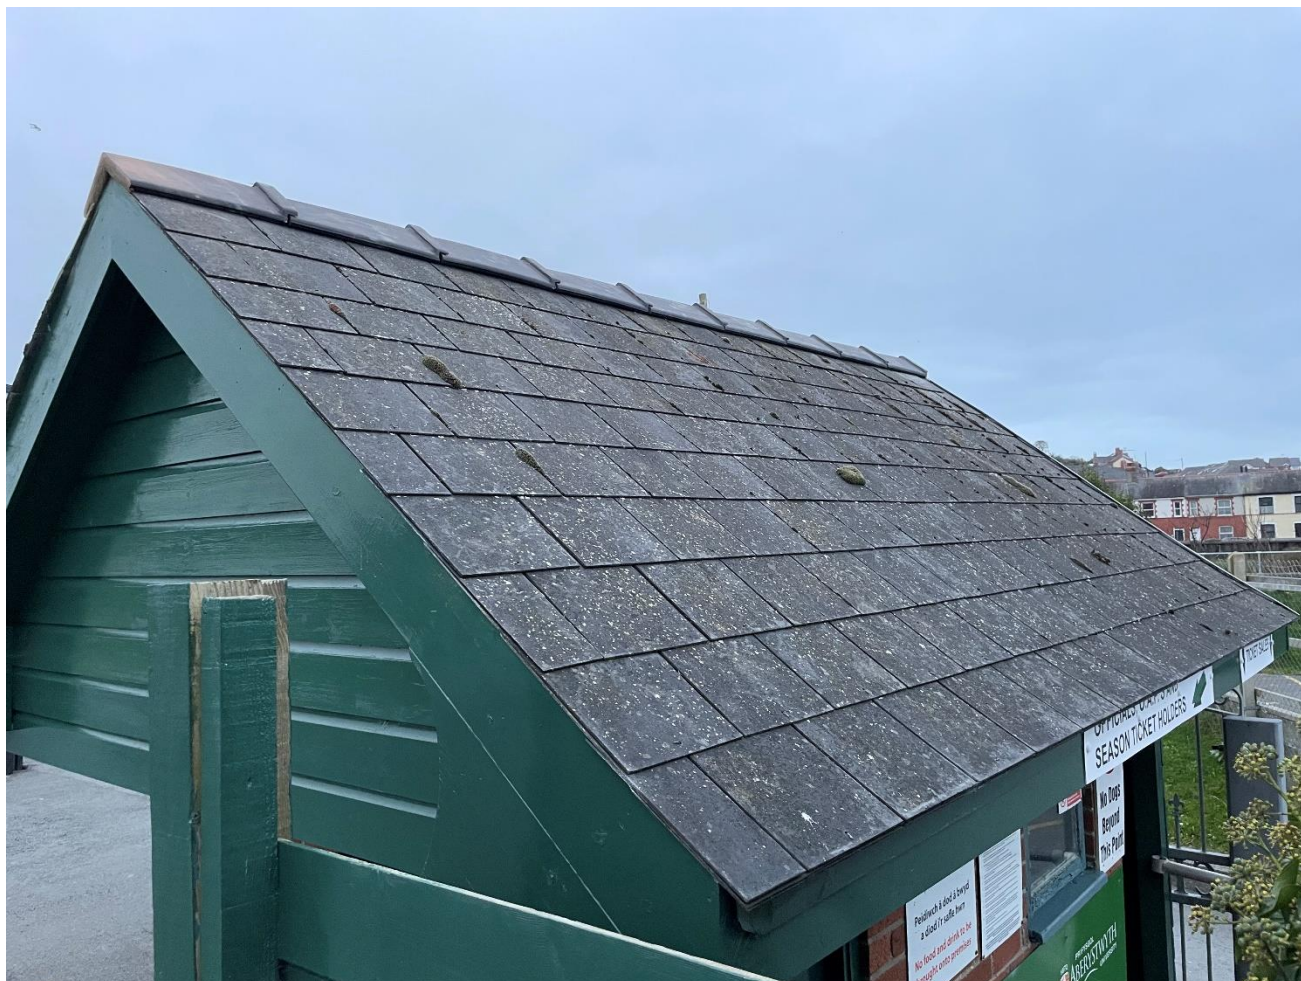
Structure E: Main Turnstile Building

This small building is brick-walled with a modern slate-roof and wooden close-boarding on the gable ends. Plastic verge-caps seal the slate ends against the barge-boards.
