PRELIMINARY PROTECTED SPECIES ASSESSMENT

**Belle Vue Hotel
Aberystwyth, Ceredigion**

Report Reference – WWE/Bats/250920

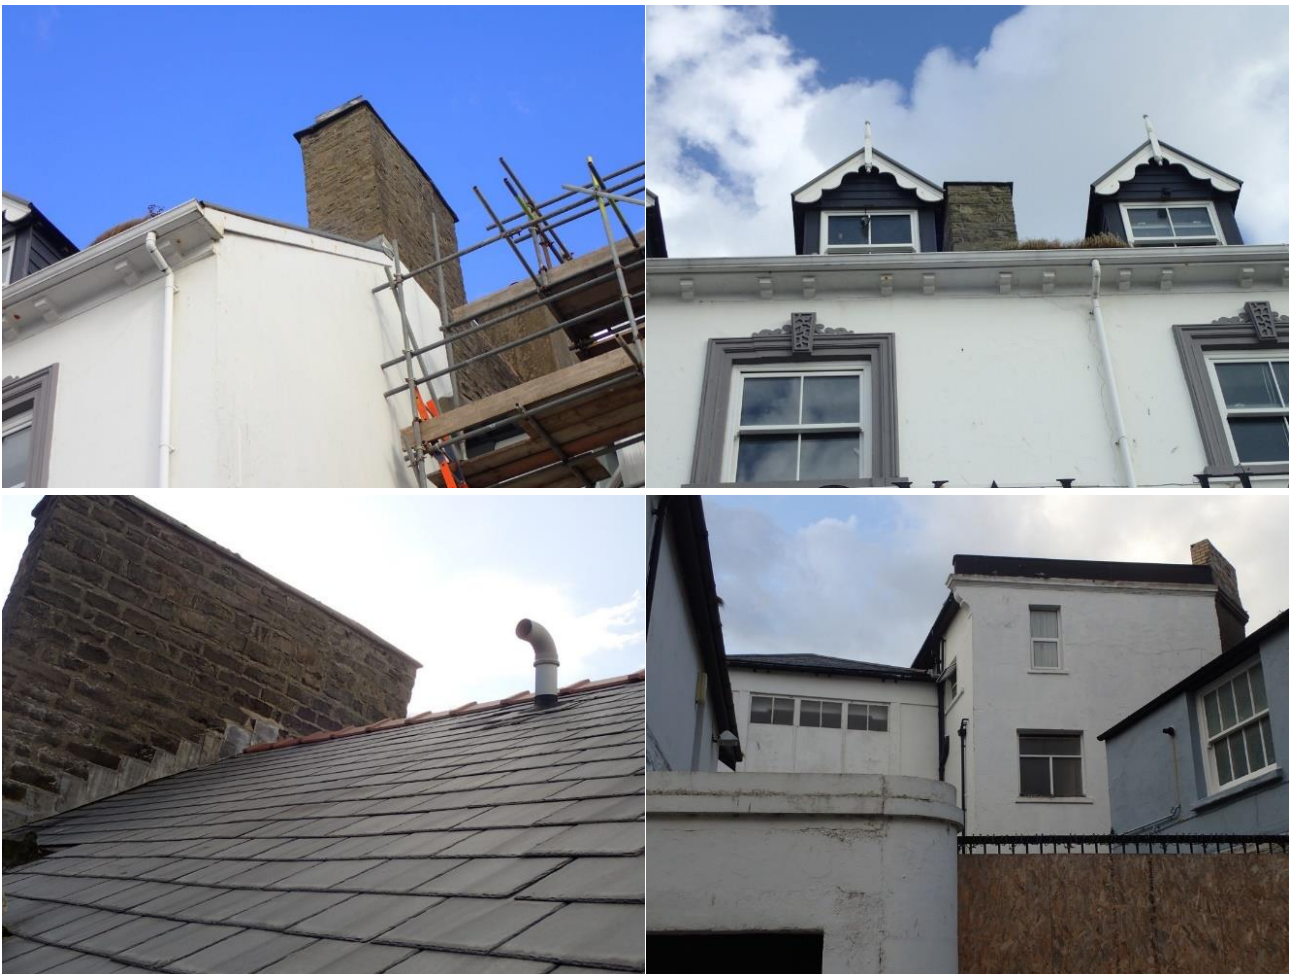
The external photos below illustrate the roof and wall structures. The west-facing section of the pitched roof has been re-roofed relatively recently, with new slates, solid insulation and a well-fitted breathable membrane below. The east-facing section has older slates with a bitumen felt membrane below the supporting battens; tears in the felt showed that there is no insulation above.

External photographs (clockwise from top-left): southern gable end; upper front (west) face; rear of building; eastern roof section

The external walls are blockwork, rendered and painted, affording no crevices. Junctions with chimney, dormer windows etc. are generally tightly sealed. The guttering and soffit boards are tightly-fitted and no squeeze gaps are apparent behind these. The chimneys to either end are of sound construction. Some original windows are intact, others are boarded. The upper level comprises a large attic room with dormer windows to the front and Velux windows to the rear. Internal walls on the top storey are stone and well-mortared. Minor cavities were apparent in the gable-end walls.

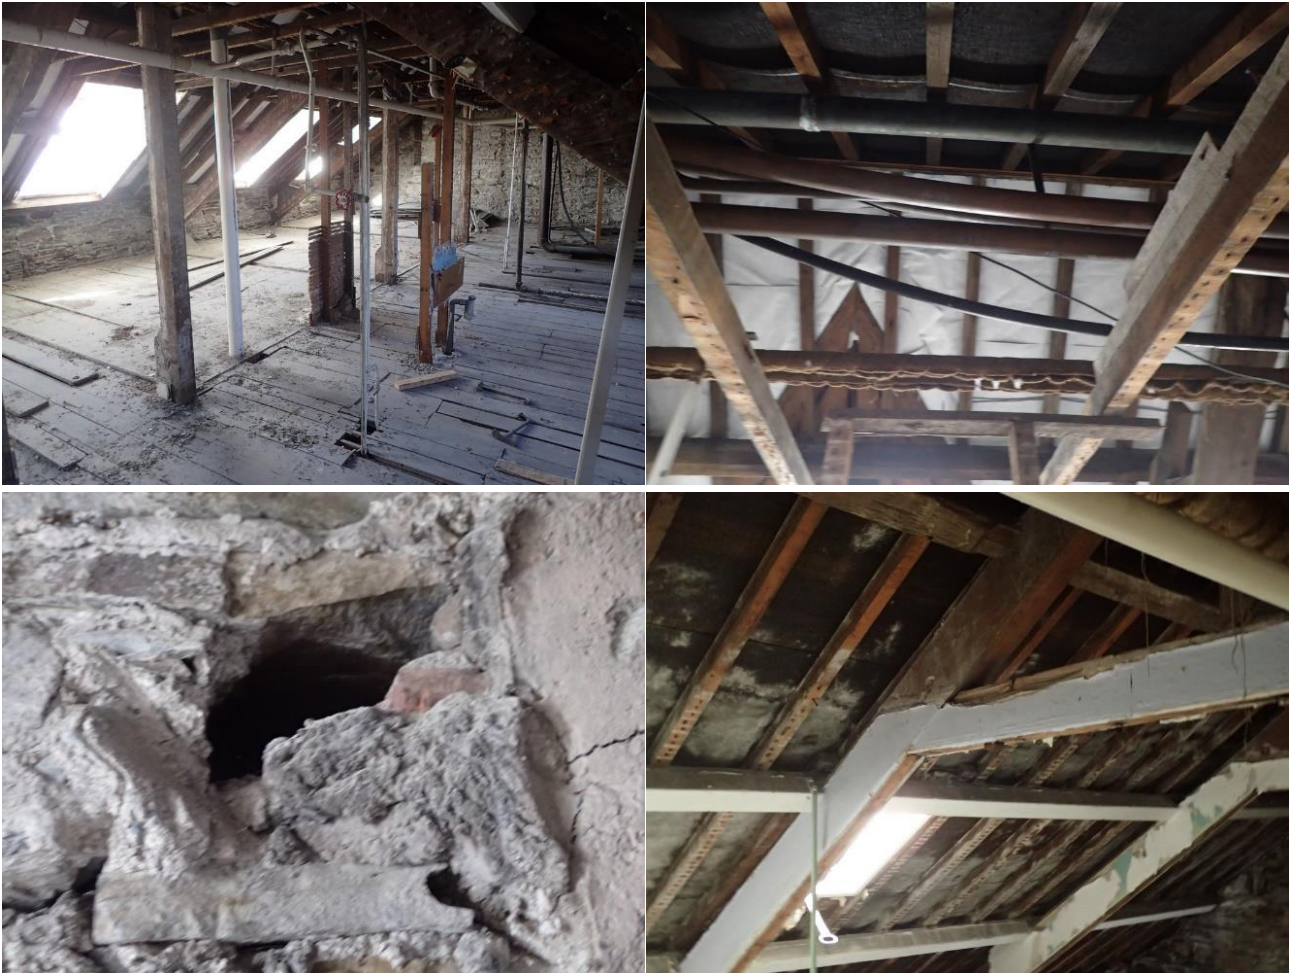
Internal photographs (clockwise from top-left): Upper storey; ridge showing newer (white) membrane and older (black) bitumen membrane; minor cavity in internal gable-end wall

potential. The east-facing roof section has a void between the slates and the membrane, but views from the Velux window here suggested that the slates are all tightly laid, with none missing, cracked or lifted. Internally, the building has no enclosed spaces suitable for a significant roost; minor gaps in the stonework on the northern gable end were the only minor potential roost spaces apparent.
